**On-farm Recharge Pilot
Projects Case Study**

Grower: Al Costa

Location: Acampo, San Joaquin County

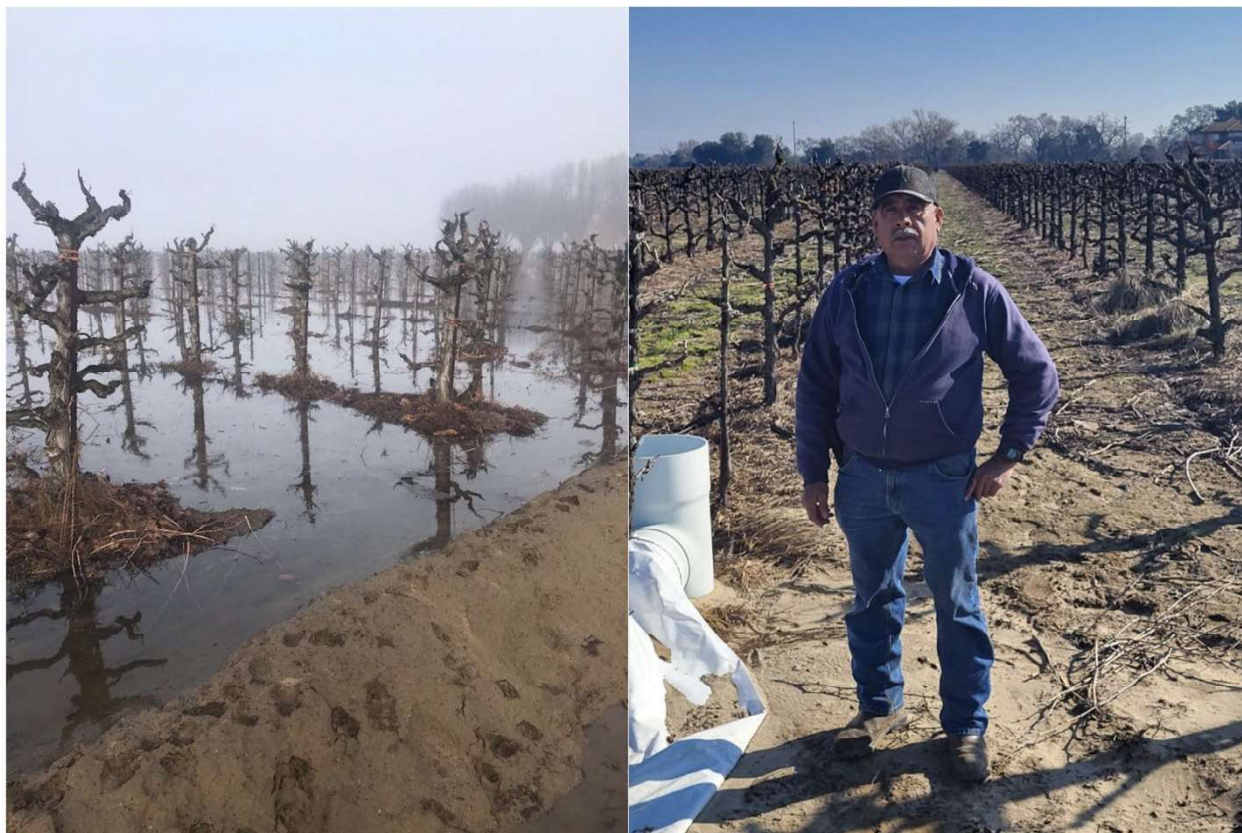
LEFT Photograph: On-farm recharge in mid-January 2022. The water head height is 3–5 inches.

RIGHT Photograph: Jose Luis, the field manager, is standing on the west side of the Costa vineyard where the recharge water is pumped into the field from about 1,500 feet of underground pipe using a lay-flat perforated temporary conveyance pipe, which is connected to risers at the head of the plant line. The field manager handles all of the logistics for successful on-farm recharge without unintended consequences. This picture was taken on January 25, 2023, about two weeks following a flood overflow breach from the Mokelumne River after on-farm recharge efforts in December 2022.

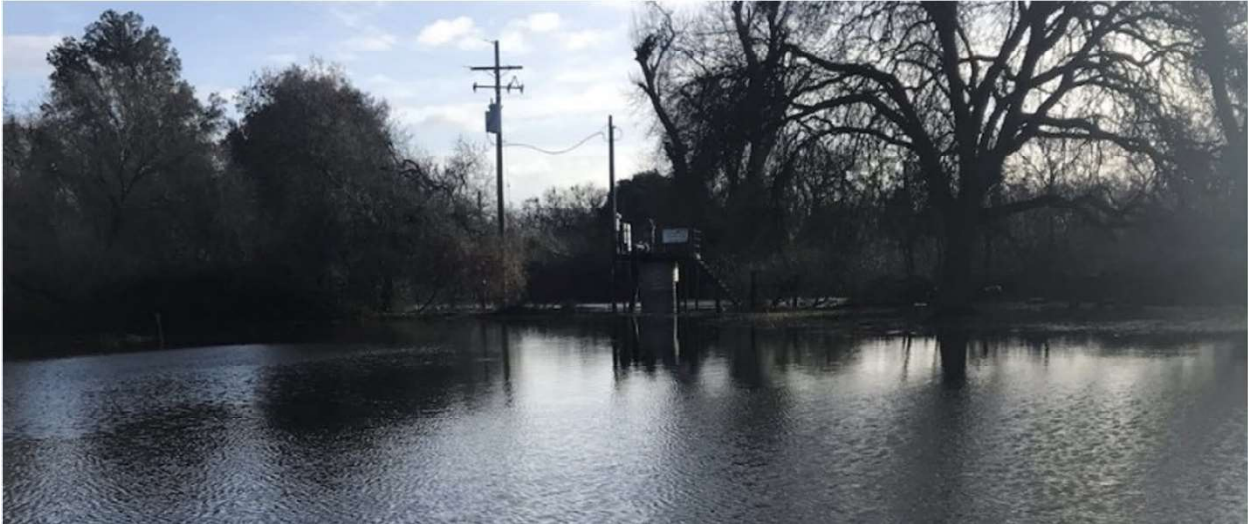
The Mokelumne River is the water supply for the Costa vineyard. But as of early January 2023, all on-farm recharge efforts ceased because of river overflow and flood conditions in Acampo, CA.
