**Grower: Christine and Erich Gemperle**

**Crop: Almonds**

**Location: Ceres, Stanislaus County**

# On-farm Recharge Pilot Projects Case Study

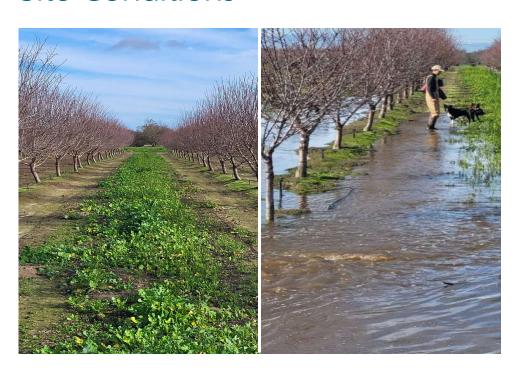
- Acreage = 36.5 acres for recharge in a 40-acre field
- Crop type = Almonds
- 20 acres, crop age = 5 years
- 20 acres, crop age = 21 years
- Land IQ rating = Moderately good
- Soil Agricultural Groundwater Banking Index rating = Excellent

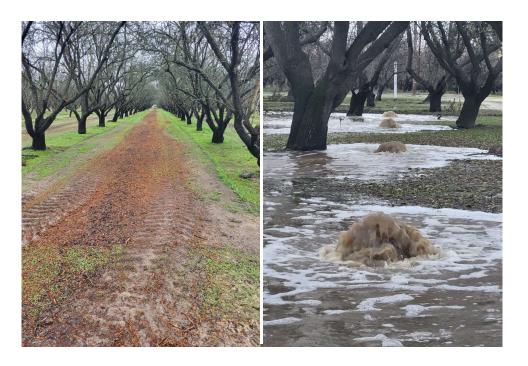
- Acreage = 18 acres for recharge (control field 20 acres)
- Crop type = Almonds
- Crop age = Mixture of 21 years and 28 years
- Land IQ rating = Good
- Soil Agricultural Groundwater Banking Index rating = Good

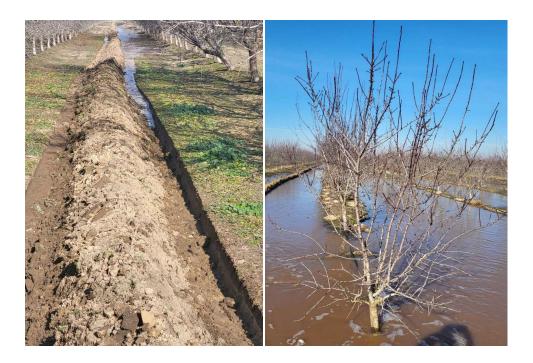
- Acreage = 13 acres for on-farm recharge
- Crop type = Almonds
- Crop age = 7 years
- Land IQ rating = Excellent
- Soil Agricultural Groundwater Banking Index rating = Excellent
