Grower: Don Cameron, Terranova Ranch

Crop: Almonds

Location: Helm, Fresno County

On-farm Recharge Pilot Projects Case Study

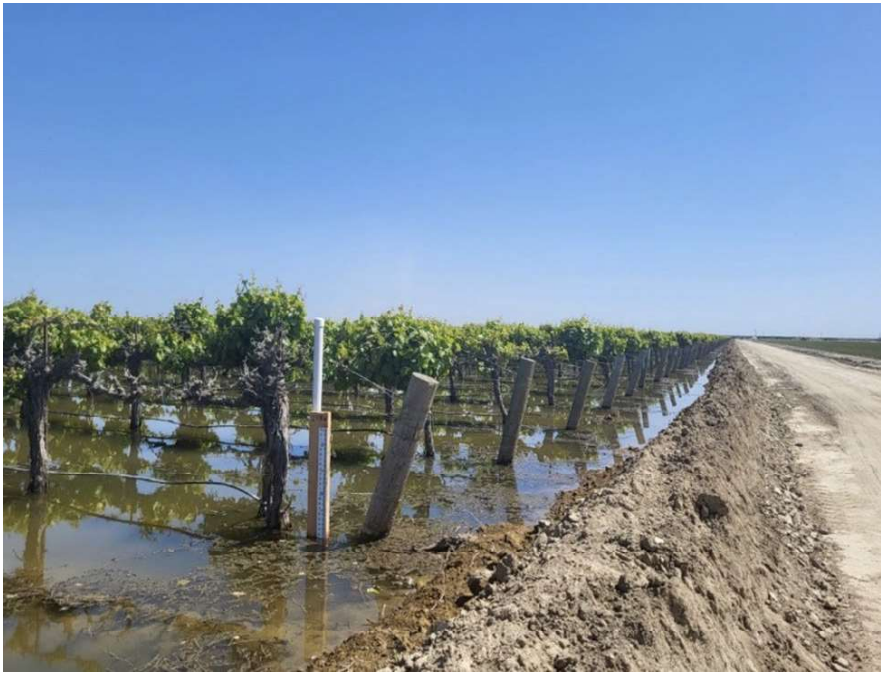
Above photo note: Mr. Cameron started recharging this field in late-March 2023 and has included it in his goal to recharge 30,000 acre-feet at Terranova Ranch. Ruby red wine grapes seen here on April 21, 2023.

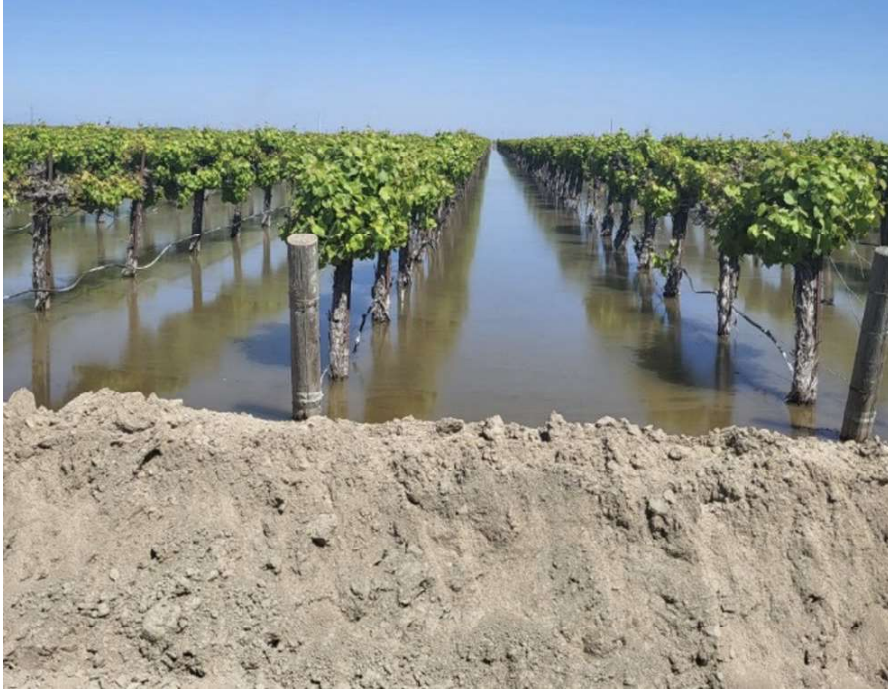
Above photo note: Ruby red wine grapes on-farm recharge in mid-April 2023 with a 3-foot berm on the outer perimeter of the orchard to ensure water stays in the targeted field. The water has a head height of approximately 1 foot.

Category	Details
Source of water	Liberty Mill Race Ditch Company
Maximum diversion rate	4–5 cubic feet per second.
Method of diversion	Pumped into the Terranova canal ditch from the 4-gate turnout at the Kings River North Fork.
Cost of water	\$4 per acre-foot of surface water.
Field preparation and management during recharge	Berm the field every 10 rows at a time until the entire field is inundated 8–12 inches. This resulted in an enclosure that was about 100 feet wide and 0.25 mile long.
Nutrient management	The grower applies nitrogen (UN 32) in the fall prior to dormancy to promote higher nitrogen carryover into the spring. This enables him to avoid the need for initial fertilizer applications (or allow for lower inputs) in anticipation of potential recharge opportunities that typically occur in the spring in the Tulare Basin.
Average inundation height	6–8 inches.
Duration of inundation	Duration of flood condition was approximately 1 week.
